Influence of restoration surfacing on service properties of soil pump shafts

The research contains analysis of primary defects of soil pump shafts. Examined is influence of quantity of restoration surfacing on wear resistance of restored parts.

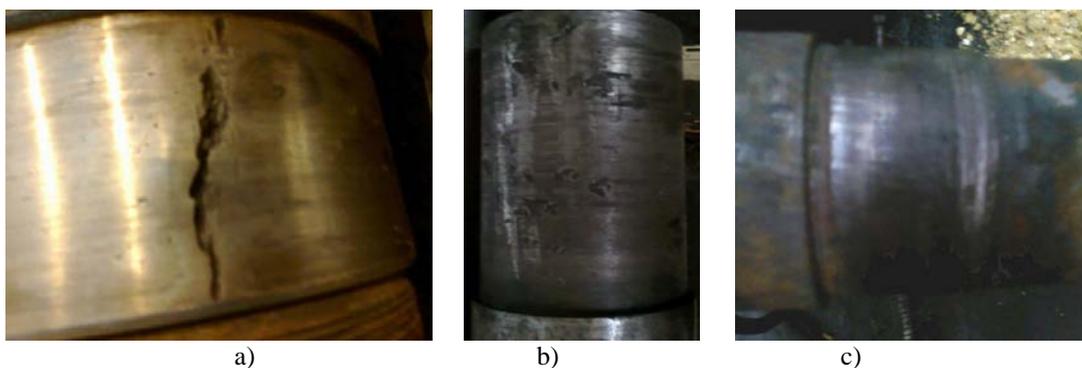
Primary defects got by shafts in the course of their exploitation are as follows: surface deterioration (picture 1, c); ripping out of metal (picture 1, b); cracks (picture 1, a), defects, deformations, changes in mutual placement of surfaces [4].

Figure1. Primary defects of soil pumps shafts got in the process of exploitation

In the result of defects analyzing it was established that about 90% of shafts fail to work because of wear they get in the process of exploitation. Wear resistance is a property of materials to offer resistance to wearing. In the course of wearing we deal with the process of surface layers destruction by means of friction. This process leads to gradual change in size, form and surface condition of parts. Wear results in lowering exactitude of conjugation, reliability and

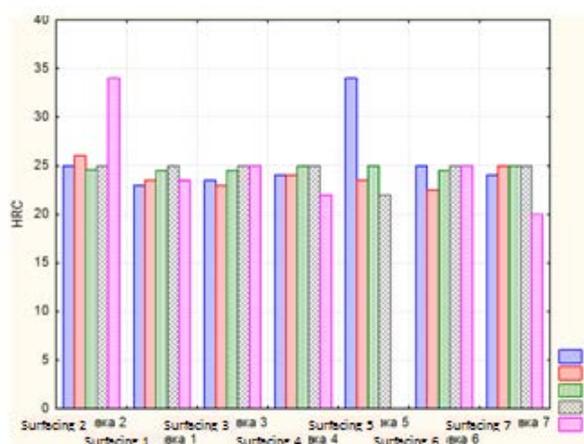
following diagram (picture 3). Having analyzed changes of hardness, we can conclude that hardness rate decreases the more numerous restorations by means of surfacing are.

1,2,3,4,5 – points of measuring hardness of samples
Figure 3. Diagram of hardness distribution on the cross-section of parts without influence of fatigue strength

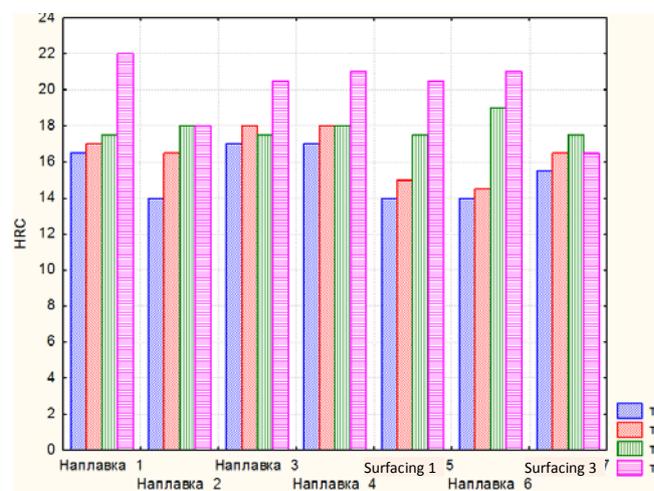
1,2,3,4 – points of measuring hardness of samples
Figure 4. Diagram of hardness distribution on the cross-section of parts having worked out their resource.

On the diagram we can see that influence of fatigue strength lowers hardness on the total cross-section of the sample. And in case with the seventh surfacing significantly lowered is also hardness of surfacing layer. And in the result of this lowered is wear resistance of the shaft surface layer.
