## **Investigation of High-Duty Pipes Surface Condition with the Use of Scanning Electron Microscopy**

**T.N. Buryak, E.M. Kuzmichev, A.A. Taranenko, N.V. Yaroshenko**

*"Ya.Ye. Osada Scientific Research Tube Institute" (SE "SRTI")*

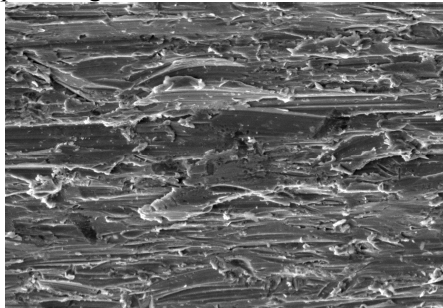
**Figure 1.** Topography of the pipes inner surface  $\varnothing 8,2 \times 0,6 \times 4200$  mm,  $\times 500$ : a – steel 08X18H10T, after abrasive polishing ( $R_a = 0,9-3,5$  microns); b – steel 06X18H10T, after electropolishing ( $R_a = 0,2-0,8$  microns).

The roughness  $R_a$  is 0,9-3,5 microns. Such surface condition does not provide achievement of the vacuum density when filling the shell with the absorber, e.g. boron carbide. During visual inspection, the inner surface is light or gray, dull, without peculiarities. Besides, after the abrasive polishing the pipes need afterpurification (washing, rubbing or wadding).

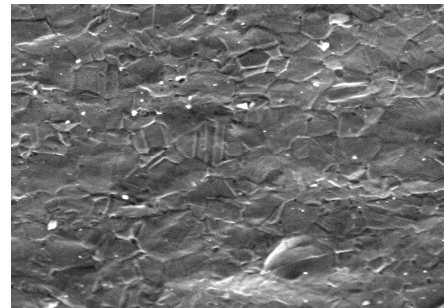
b

As a result of electropolishing the inner surface of pipes  $\varnothing 8,2 \times 0,6$  mm of steel 06X18H10T is quite homogeneous and smooth. Mostly nonmetallic and grain boundaries are visualized on it (**Figure 1b**). The roughness parameter  $R_a$  is 0,2-0,8 microns. The inner surface is light and shiny. Such state of the working surface seems to be more favorable for shells.

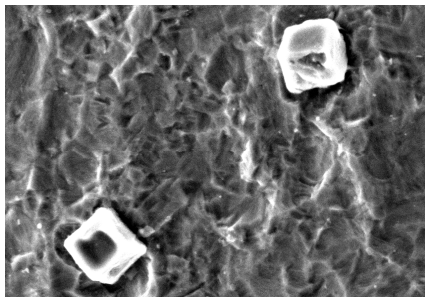
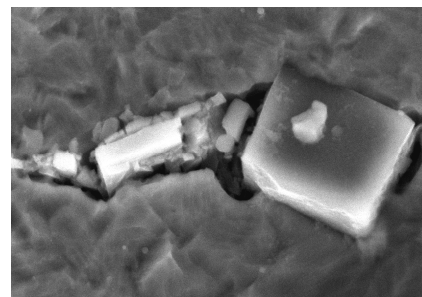
**Figure 2.** Nonmetallic impurities on the pipes inner surface  $\varnothing 8,2 \times 0,6$  mm of steel 06X18H10T: a –  $\times 1000$ ; b –  $\times 2500$

In this case, titanium-stabilized steels 06 ... 08Kh18N10T have in their structure nonmetallic inclusions, in particular, titanium carbonitride, both individual and in the cluster. Opening on the pipes surface, they can be centers of corrosion nucleation. Scanning electron microscopy can detect the presence of the impurities themselves, their structure, as well as further identify them (**Figure 2**).

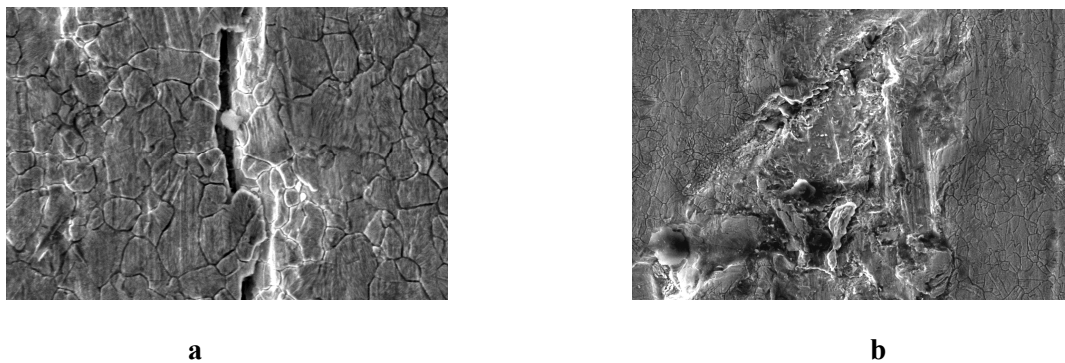
copper-nickel alloy MHЖ 5-1 defined in the standard GOST 17217 must not contain laps, blisters, laminations, deep lines and other defects deeper than 0,1 mm. The images obtained by “PЭM” showed that there were some microscopic defects on the pipes surface, determined by the way of production. E.g. microcracks, lines, traces of adhering (**Figure 3**). Not exceeding allowable depth norm, such surface defects, will certainly contribute to damage the operation of pipes at nuclear power plants, such as pitting corrosion.

**Figure 3.** Topography of the pipes inner surface  $\varnothing 19 \times 1$  mm of MHJK5-1 alloy: a –  $\times 500$ ; b –  $\times 250$
