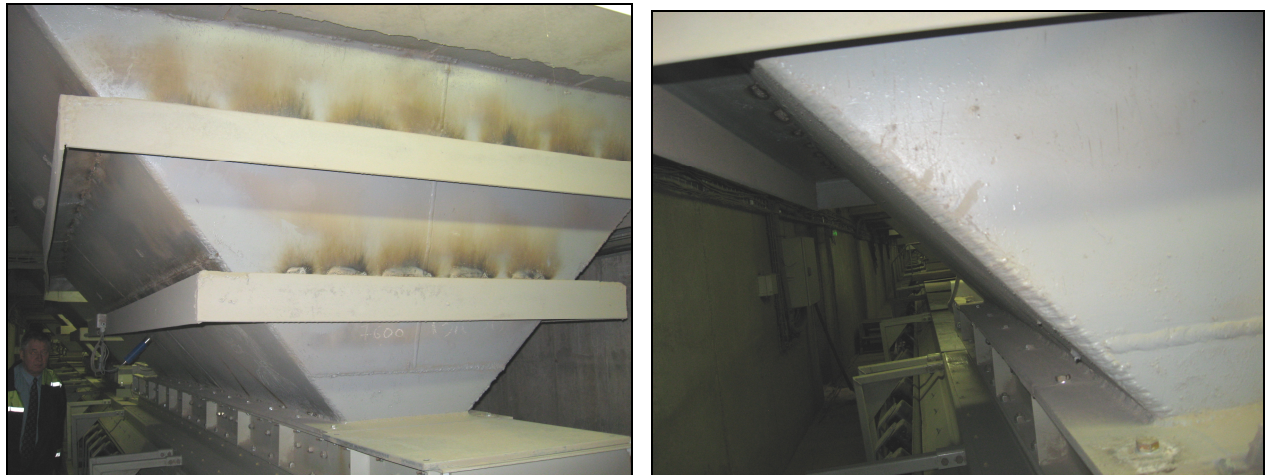
Figure 3. Deflections of the bearing elements of unloading hoppers of the capacitive structure

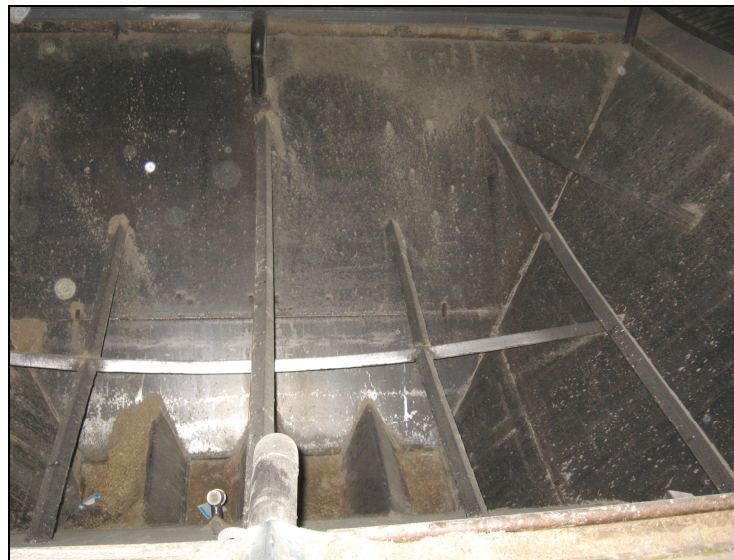
Figure 4. Deflections of the retaining steel strands of unloading hoppers of the capacitive structure

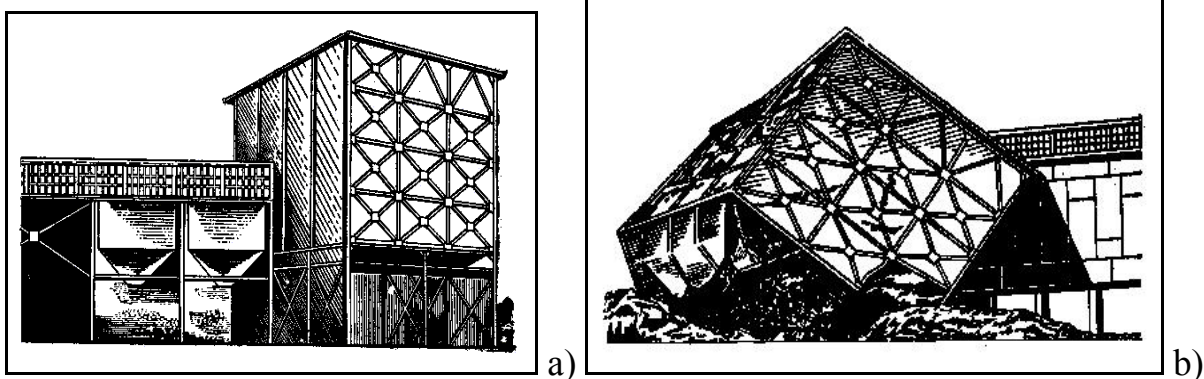
cleaning complex; the stands were significantly bent with at 180° , but without breaking the steel.

Checking calculations of the hopper structure, performed according to the design norms showed that it has sufficient strength, but flexibility of the support stands is much higher than allowed.

Exactly that was the main cause of the accident. The storage hopper was built without a project based on the rough plans taken from the same hopper, built earlier at another state farm. The height of the stands was increased from 4 to 5.3 m without performing proper checking calculations.

Figure 5. Storage hopper before (a) and after (b) the collapse
