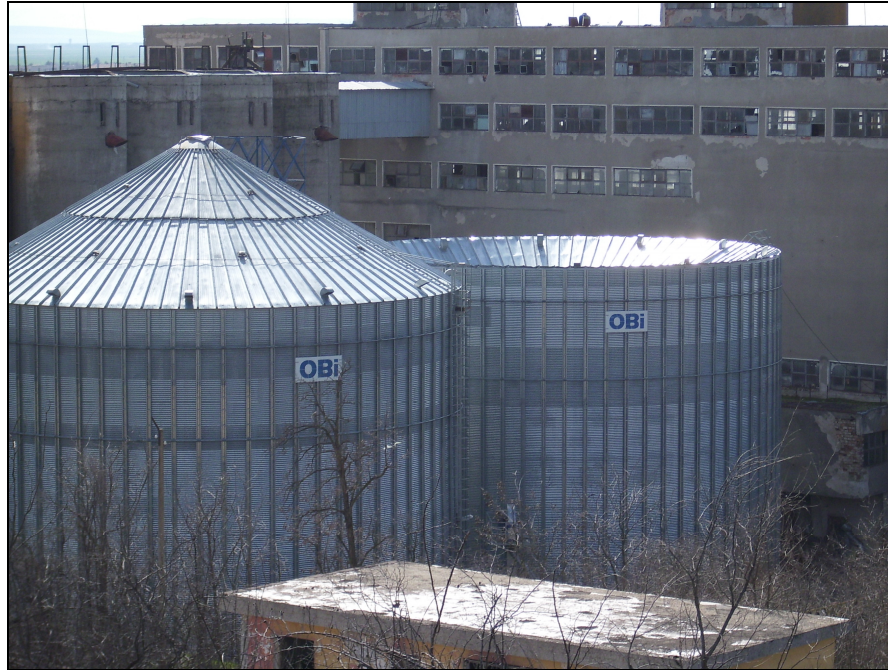
Figure 7. Bend of the silo roof

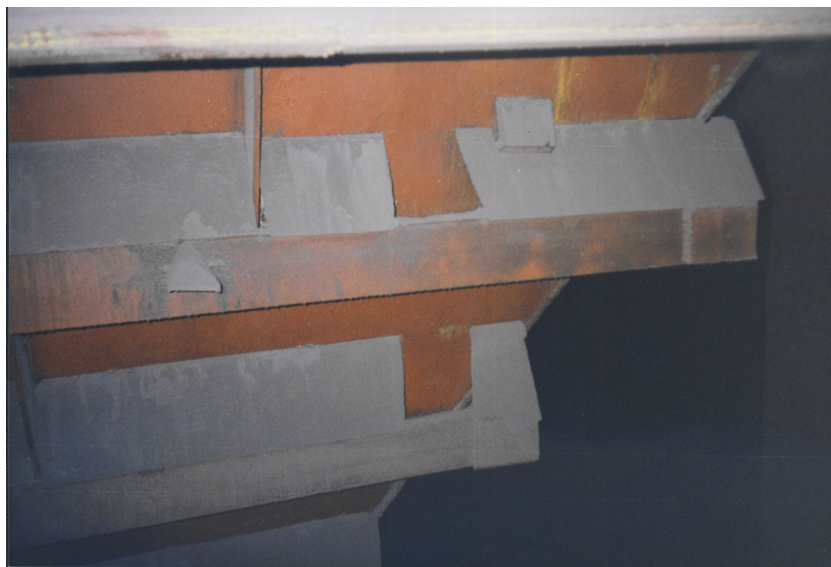
steel sections in this case can be up to 0.5 mm/year. Second of all, performing high-quality corrosion-resistant coating of beaded capacitive structures with many protrusions, deepening, representations and hard-to-reach places is rather problematic (**Figure 8**). Therefore, in practice, the issue of operation was quite often neglected and then corrosive wear can reach 60-80%.

Figure 8. Corrosion damage of hopper walls
