## **Repair of conveyer belts and expansion bellows of bell-less tops of blast furnaces by elastomers of cold vulcanization**

The article covers the results of performed tasks concerning repair of metallurgical equipment including conveyer belts of by-product coke plant and sintering plant and also compensators of bell-less tops of blast furnaces with the help of modern polymer materials, allowing to fulfill hermetization of various assemblies without removal of equipment on-site of exploitation.

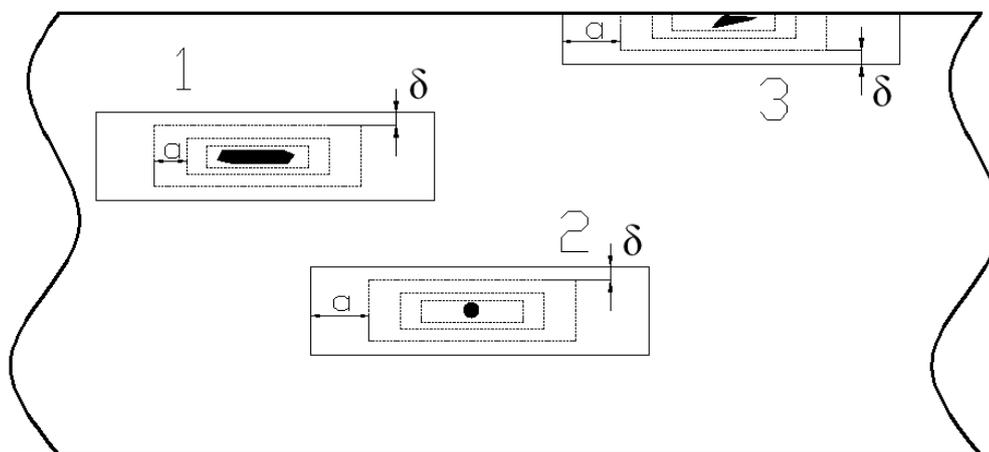
Let us consider first the recovery process of conveyer belt. Their damage in the process of exploitation may be of various characters. Figure 1 shows the main and possible types of conveyer belts damages, taking place on one of the coke and by-product processes. Among these are:

- Long cuttings of any length (both interface and blind);
- Reach-through breakdowns of conveyer belts;
- Damages of belt borders;
- Crossed cuttings of rubber-fabric belts up to 20% of the belt.

**Figure 1.** Possible types of conveyer belts damages: 1- long cutting; 2 - reach-through breakdown; 3 – damage of belt border.

Traditional technology of reclamation work lies in the following. Repair of reach-through breakdowns and cuttings of cloth belt 20 – 25 mm in size are fulfilled on the conveyer in the area of minimum tension of the belt.

Primary sectoring of stages of fault locations with the help of samples is fulfilled. The samples feature the set of rectangles. The smallest sample should recover the damaged piece not less than  $\delta=10$  mm across-track of the belt and  $a=60$  – 100 mm – lengthwise (fig.1).

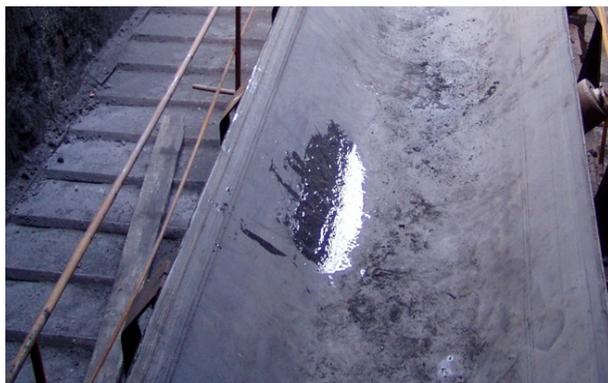
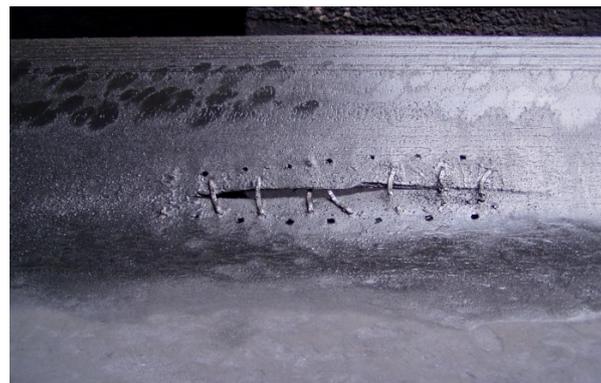
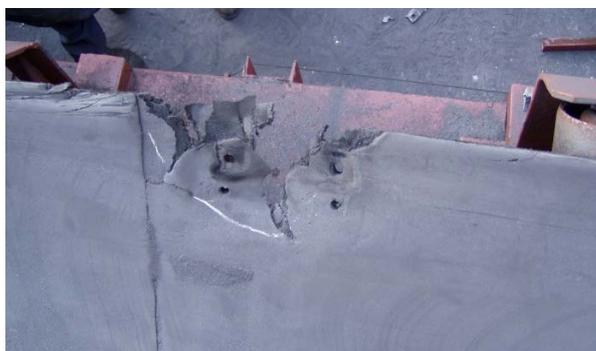
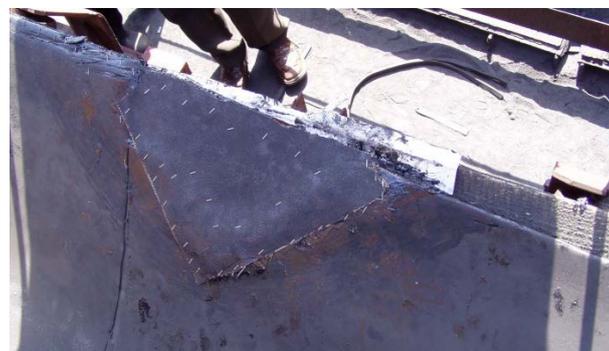
**Figure 2.** Damaged areas of conveyor belt before (a) and after (b) reclamation:  
1 – long cutting;  
2 – damage of belt border.

Application of this material during repair of defective belt areas at one of the by-product coke plants allowed to reduce repair time and also

the delay of conveyer up to 1-2 hours. Reclaimed by such material areas of the belt with various damages are shown in the figure 2.

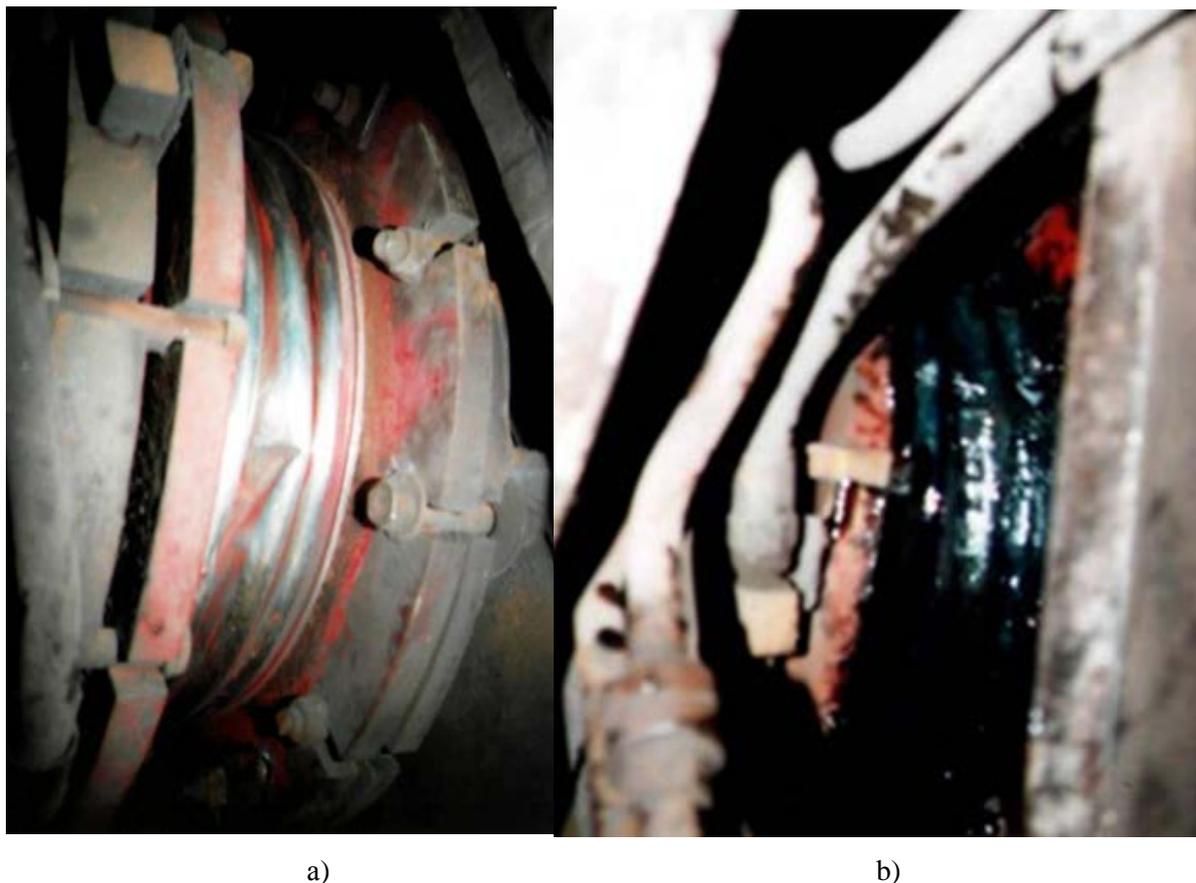
**Figure 3.** Reconstruction of compensator DU 400 before airtight packing a) and after b).

In the cases when it is necessary to eliminate numerous holes, formed as a result of jam on the compensator axis of a shuttle DU 400 mm, there was used a technique of creation of “diagum” polymer solid bed on a top of stainless surface of compensator with application of glass fabric, which is also sodden with this polymer. This technique was repeated twice.

It was rather complicated to secure airtight packing, considering the fact that this work was performed on the acting blast furnace and space-limited environment for repair (the distance between support bearing of underslung gearing of shuttle and between block body of burden gaps was not more than 600 mm). However in 8 hours the repaired unit was operated and provided hermiticity of compensator within 1.5 hours till turn around maintenance(fig.3).

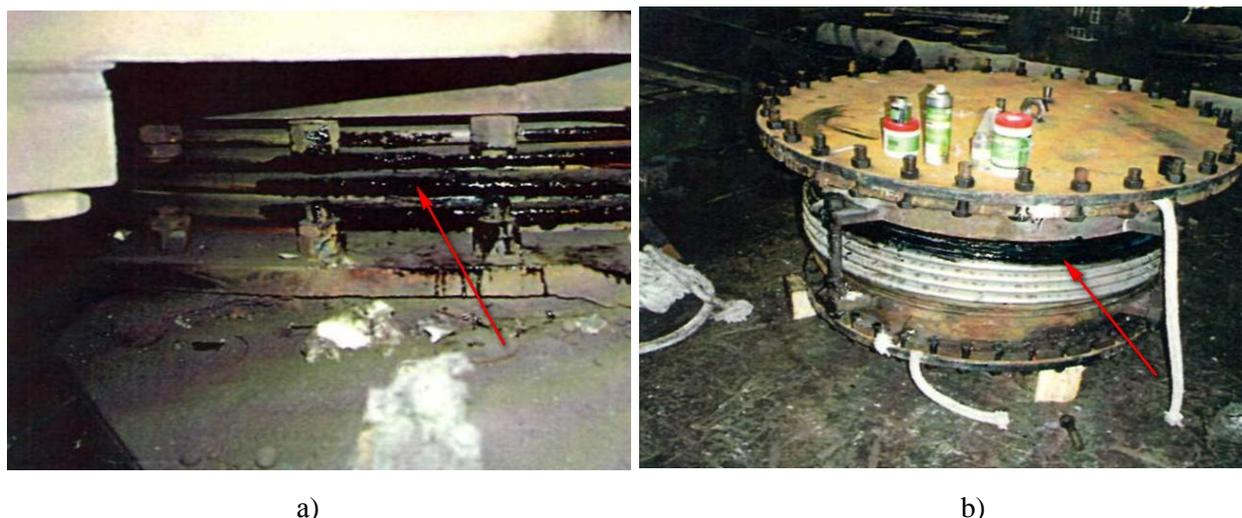
One more repair, which is fulfilled on the operating furnace, referred to hermetization of the blow with the length 150 mm and width 10 mm on the compensator DU 2000 mm. In this case the patch on the defective area was put on with the usage of “diagum” with glass fabric overlapping the defective area twice across the length and width (fig. 4a). The another case of compensator repair refers to recovery of hermiticity of welded seam of double-flanged compensator. In case of

welding of stainless thin shell with steel flange of nonuniformity of the seam also lead to “blows”.

**Figure 4.** Recovered compensators DU 2000 on the blast furnace (a) and DU 1200 in conditions of hermeticity test in the machine workshop (b).

To exclude this phenomenon before installation of compensator on the blast furnace, it is checked for hermiticity by means of air discharge. Such check revealed air losses in some areas of welded seams, in consequence of which it was decided to encapsulate by “diagum” (fig. 4b). Compensator on the blast furnace was operated for long term without any notes.
