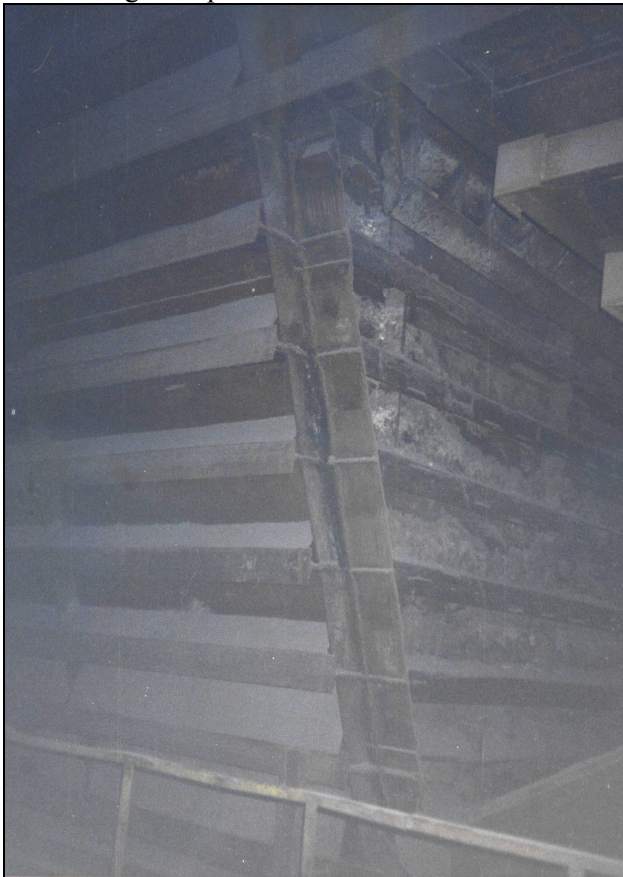
**Figure 2.** Repaired bearing stiffeners of the hoppers

Thus, the second main cause of the already mentioned accident of cement silo is wrongly accepted force distribution in the link-up zone of the hopper with the vertical part, resulting in a separation in this place. The same situation was observed in the hoppers of the Kuznetsk and Chelyabinsk Metallurgical Plants, known to the author from interviews with experts. Rather vulnerable area is the connections between the reinforcing plates of the hopper, which quickly wear out and that's why are always in need of repair. **Figure 2** shows an example of damage of these items, photographed by the author at one of the existing steel plants.
